# Manhole Inspection Summary

Manhole # S57E\_\_011MH

Insp Date: **6/30/08 10:01 AM**

**Location** Address: **3925 e lombard st**

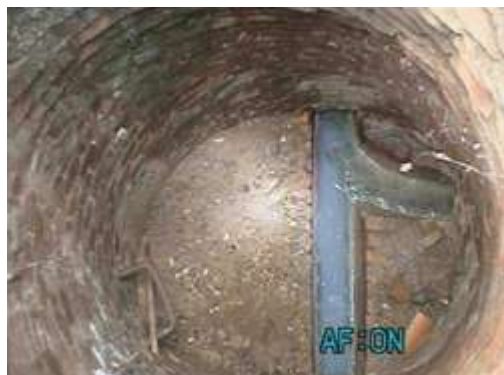
Top View

location view & above grade 1inch

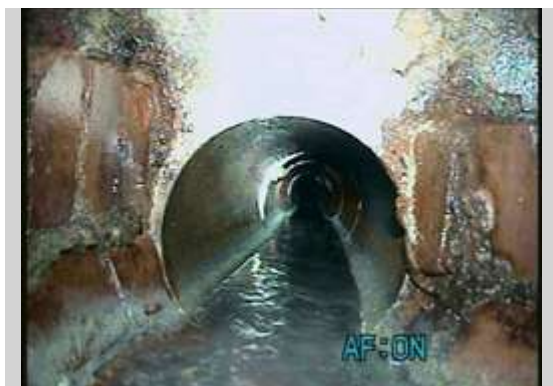
12 O'Clock Outflow

8 in. Circular Gravity Sewer  
Pipe Out @ 12 O'Clock

Invert Depth: **10.19** (ft.) Flow Characteristics: **Fast**

Deposits: ☒ None ☐ Mud ☐ Sludge ☐ Debris ☐ Grease

Infiltration: **None** Pipe Seal Cond: **Unknown**

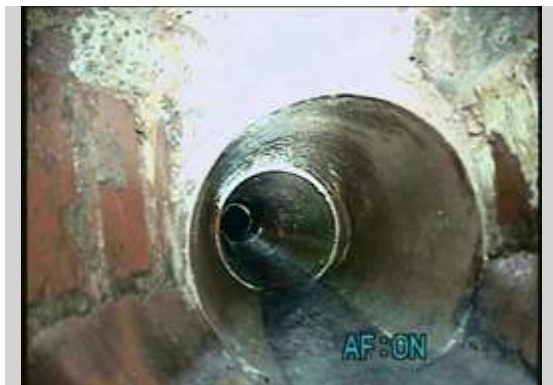
3 O'Clock Inflow

8 in. Circular Gravity Sewer  
Pipe In @ 3 O'Clock

Invert Depth: **10.16** (ft.) Flow Characteristics: **Fast**

Deposits: ☒ None ☐ Mud ☐ Sludge ☐ Debris ☐ Grease

Infiltration: **None** Pipe Seal Cond: **Unknown**

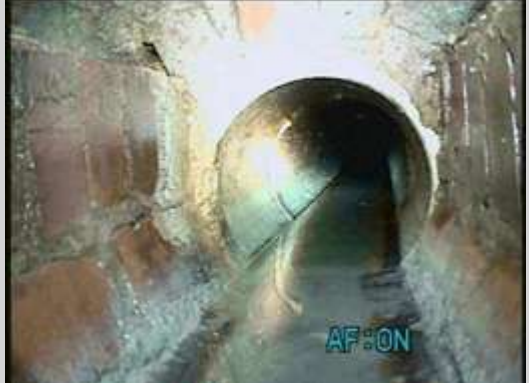
6 O'Clock Inflow

8 in. Circular Gravity Sewer  
Pipe In @ 6 O'Clock

Infiltration: **None** Pipe Seal Cond: **Unknown**
